Structural design for seismic isolation

-design practice, construction and maintenance-

Structural Engineer Engineering Department Nikken Sekkei Ltd.

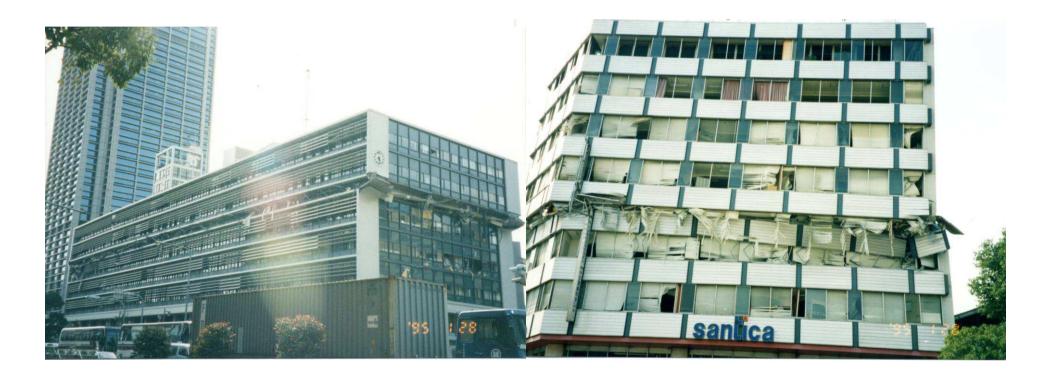
Damage by the Kobe Earthquake

Some buildings built by old design standard was damaged in the Kobe Earthquake.

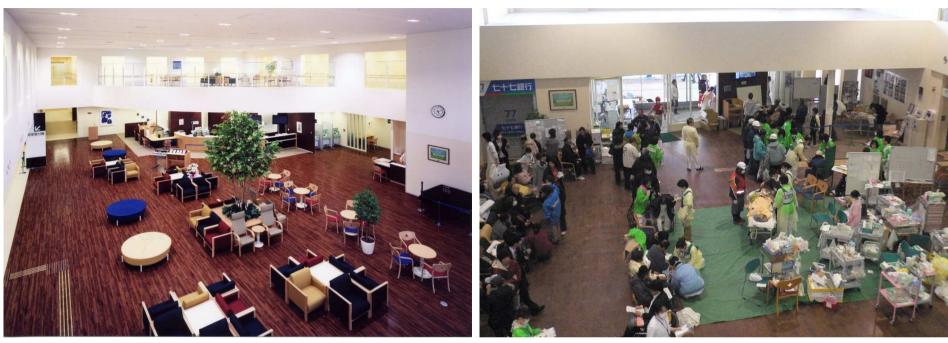
Lobby (in normal condition)

Lobby (after the earthquake)

This hospital was designed so that the required function is maintained even after an earthquake.

The seismic isolation system protected the building function during the earthquake, and the hospital operators could establish emergency responses immediately.

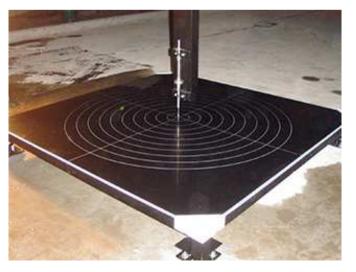
Orbit Record: How much this building deformed ?

Orbit Record on Metal Sheet

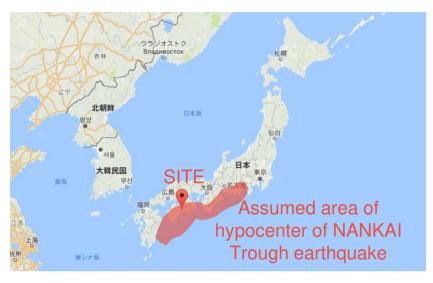
Structural Challenge: The site is located at the assumed hypocenter of NANKAI Trough earthquake which might be M9 class. Mega earthquake and Tsunami should be considered in the design.

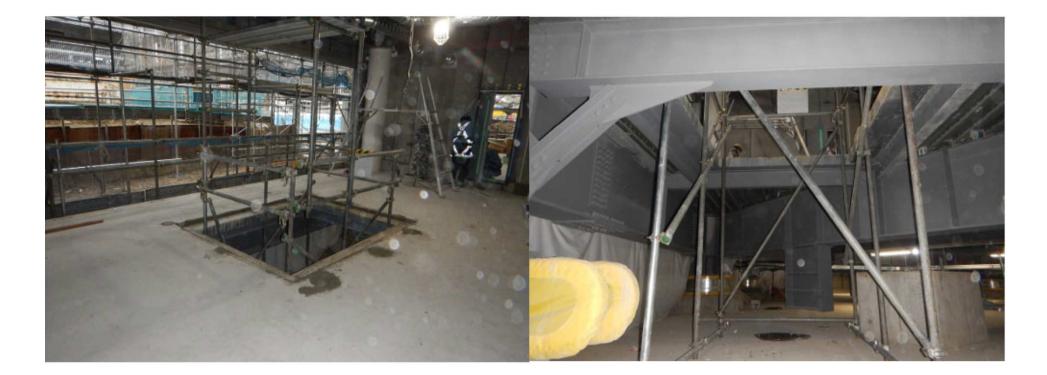
Inspection and replacement of Isolation Device

The access for replacement should be considered when designing the building. A machine hatch about 3m × 3m is required.
